# University Glen Townhouses

## Level 2 Reserve Study

| <b>Type of Study</b> | <b>Update with Site Visit</b> |
| <b>Date of Site Visit</b> | <b>12/18/2024</b> |

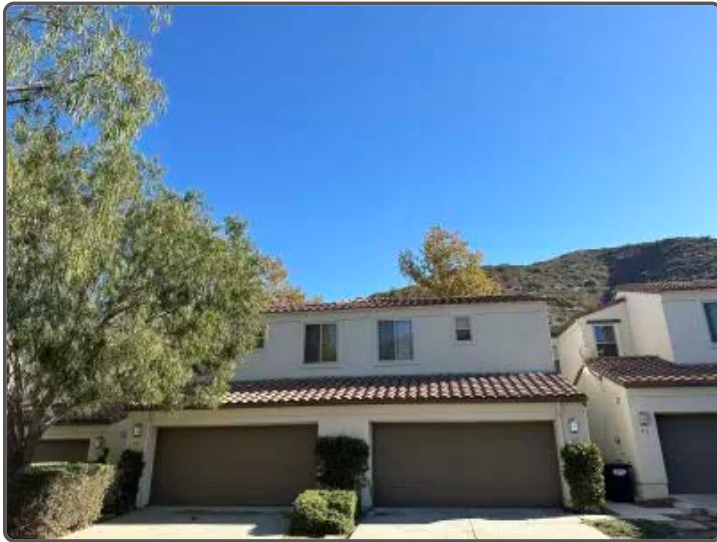
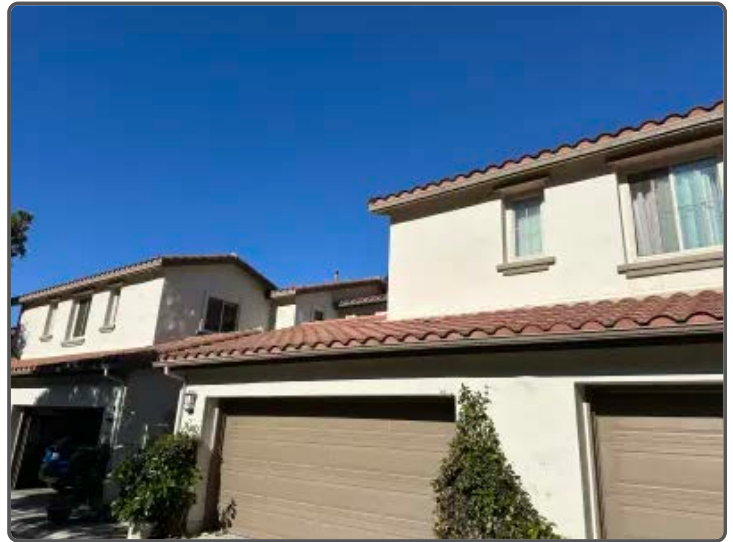
Comp # 106 Tile Roof - Replace

It was reported that the association has experienced local areas of leaks with the tile roofs. These roofs should generally experience a useful life of approximately 30 to 35 years with regular maintenance and local repairs. Remaining life based on current age.

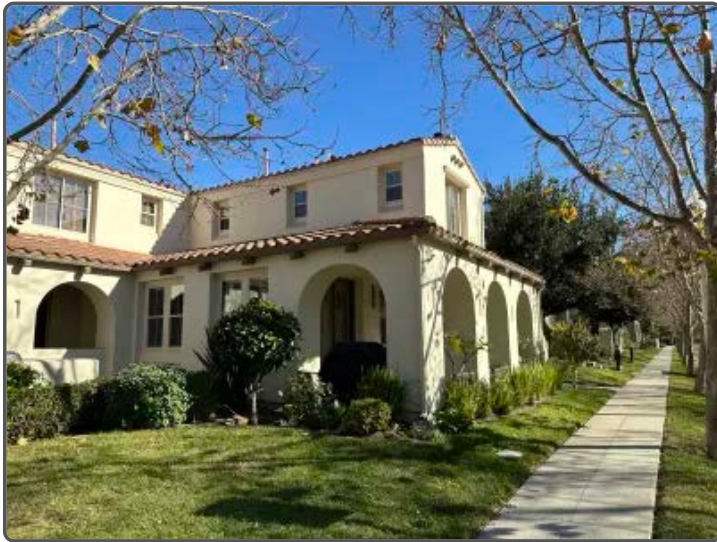
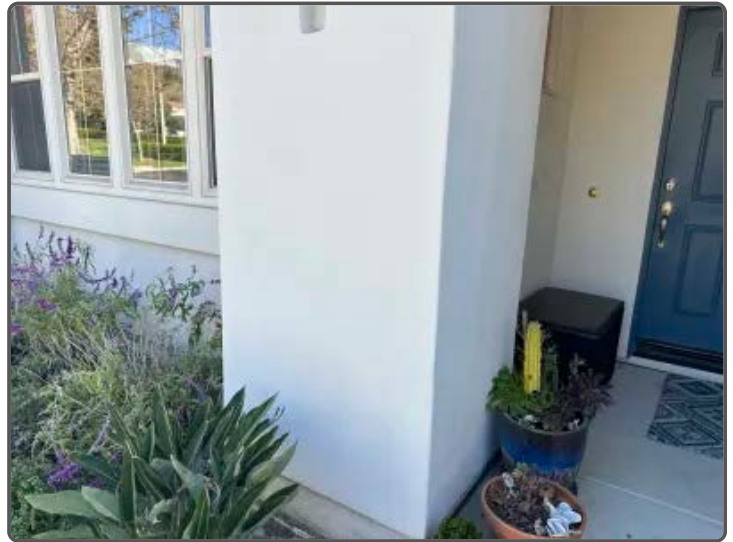
Comp #      201      Stucco Surfaces - Repaint

The painted stucco surfaces are generally in fair condition. It was reported that the townhouse units were repainted in 2018. These surfaces should generally be repainted approximately every 10 to 12 years to maintain appearance and protect stucco material. Remaining life based on current age and condition.

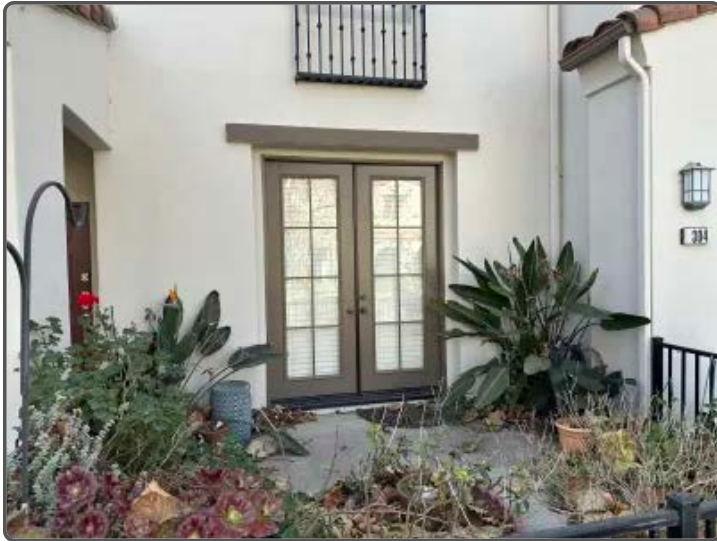
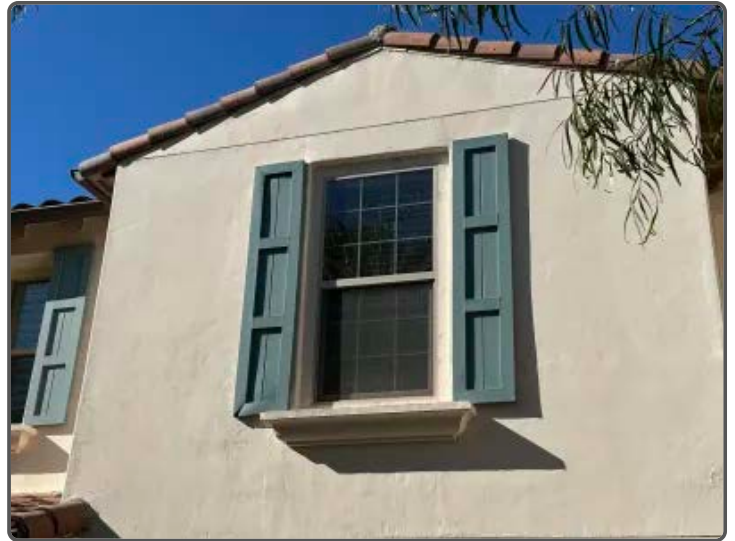
Comp # 202 Building Trim - Repaint

The painted trim surfaces are generally in fair condition. It was reported these surfaces were repainted in 2018. Expect to repaint these surfaces approximately every 5 to 6 years to maintain appearance and protect the trim material.

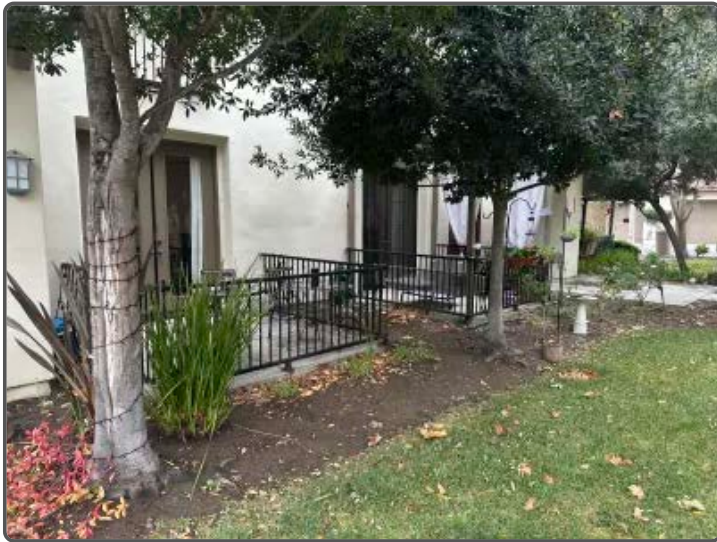
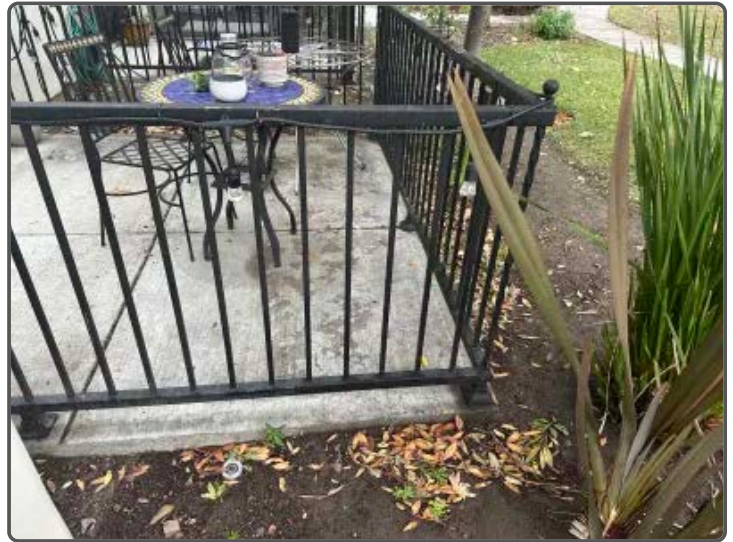
Comp # 207 Wrought Iron Fencing - Repaint

The painted wrought iron surfaces are generally in fair condition. Noted local discoloration to the painted wrought iron surfaces. These surfaces should generally be repainted approximately every 5 to 6 years to maintain appearance and protect the fencing material. Remaining life based on average condition.

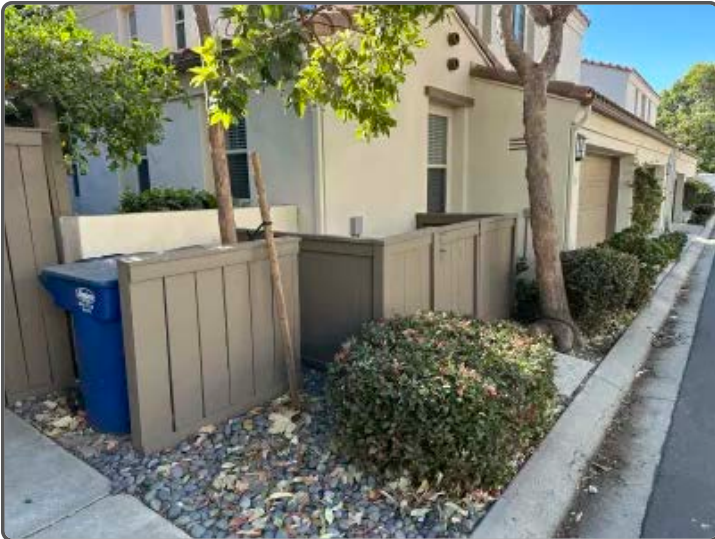
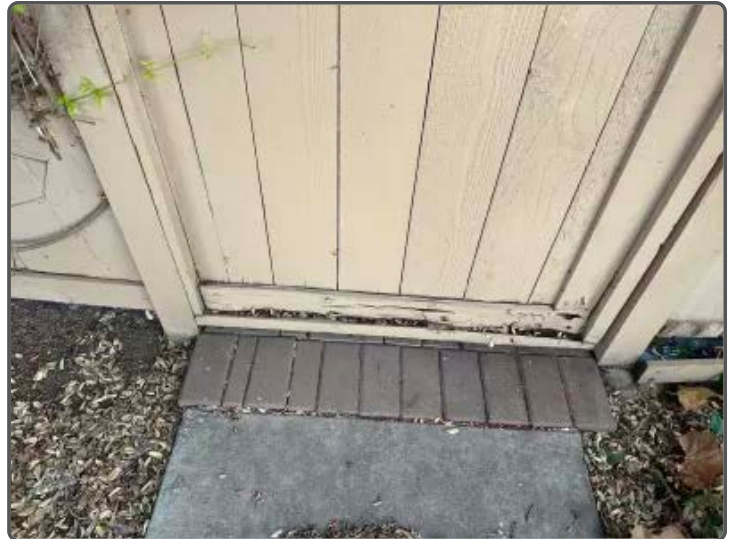
Comp # 209 Fencing - Repaint

It was reported that the wood fencing will be converted to a metal fencing in the next few years. We recommend repainting this type of fencing approximately every 5 to 6 years.

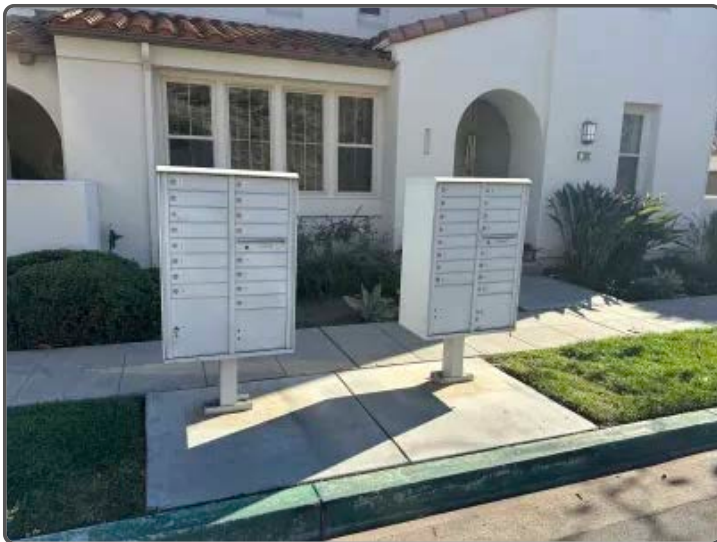
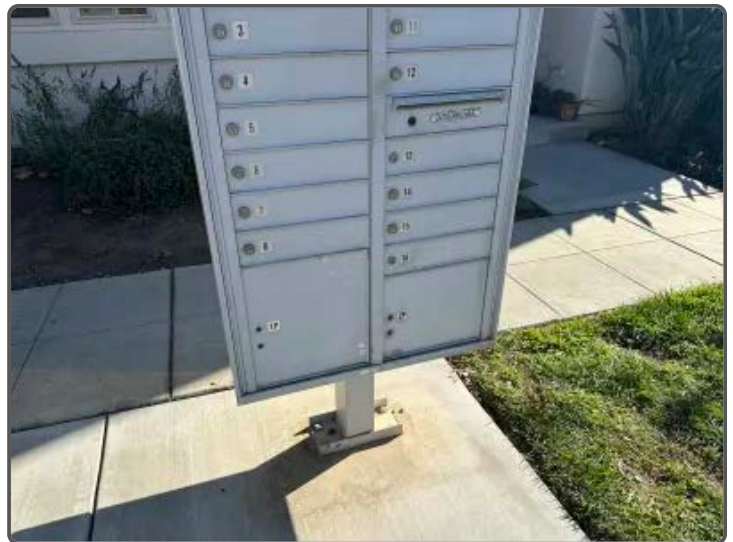
Comp # 290 Mailboxes - Repaint

Noted fading and discoloration to the community mailboxes. We recommend funding to repaint these boxes approximately every 5 years.

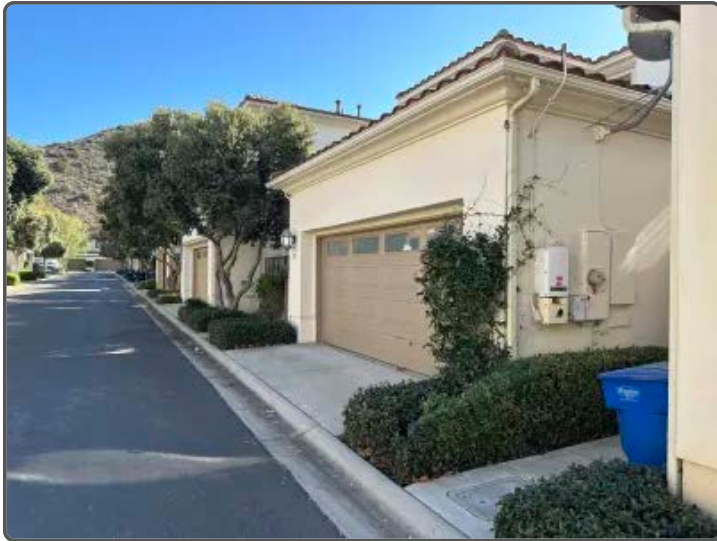
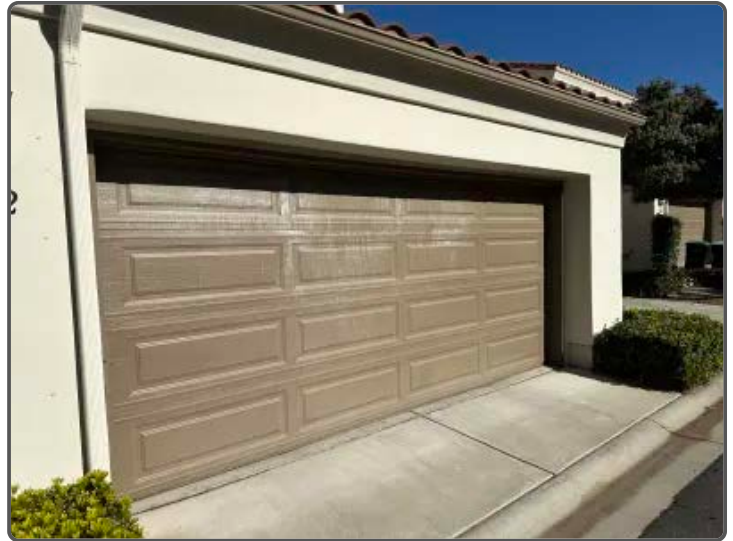
**Comp #**      **502**    **Garage Doors - Replace**

Although these doors may experience an extended life we recommend funding for their replacement approximately every 25 to 30 years.

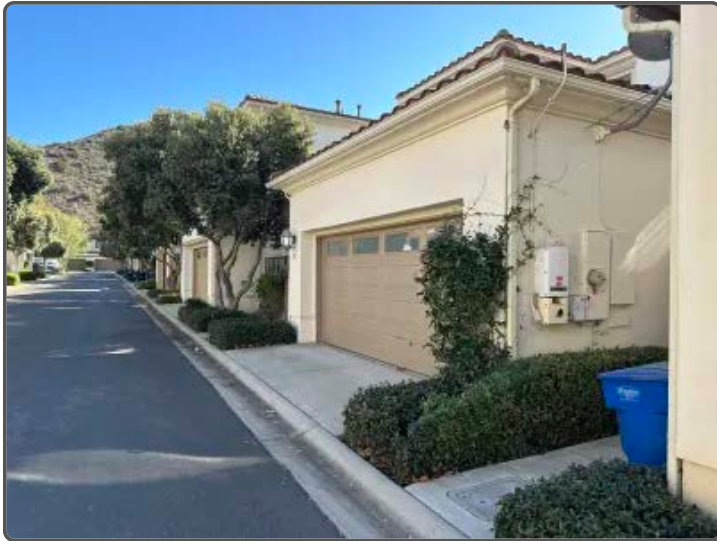
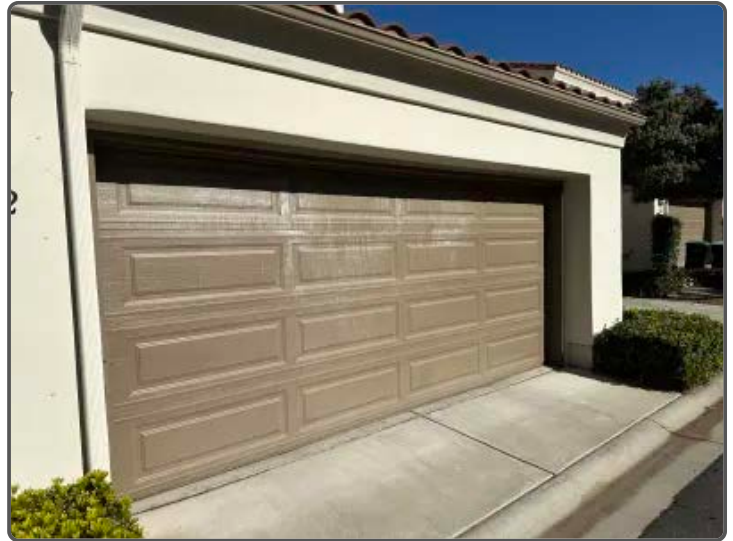
Comp # 502 Garage Doors - Replace (Completed)

It was reported that approximately 25 of the garage doors have been replaced in recent years. We recommend funding to replace these doors approximately every 25 to 30 years.

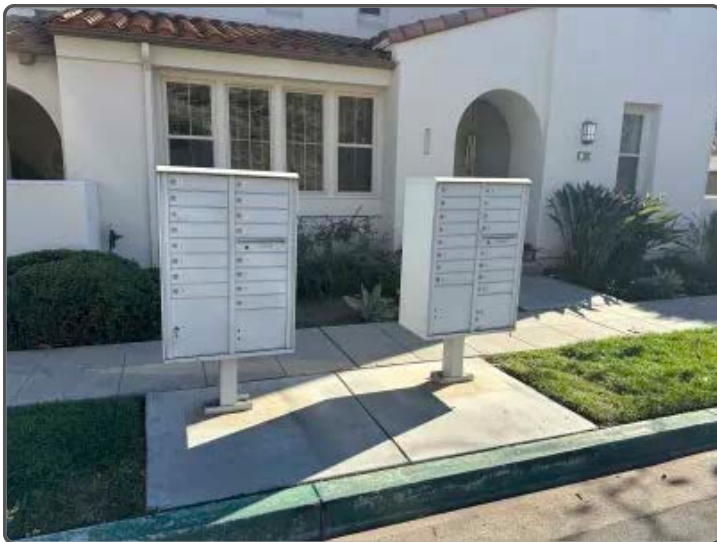
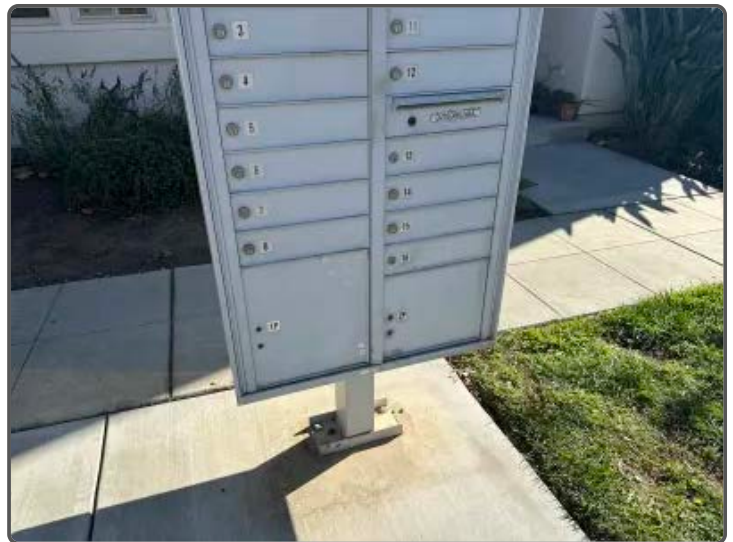
Comp # 803 Mailboxes - Replace

The mailboxes are generally in fair condition. Although these mailboxes may reach an extended life we recommend funding for their replacement approximately every 20 years to maintain appearance and function.

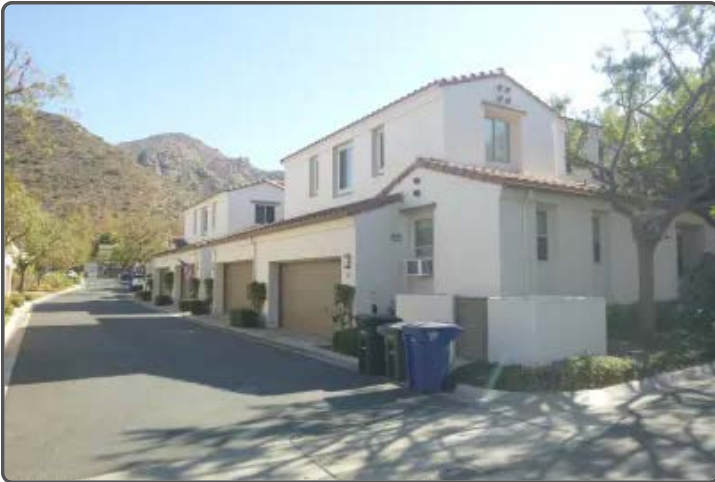
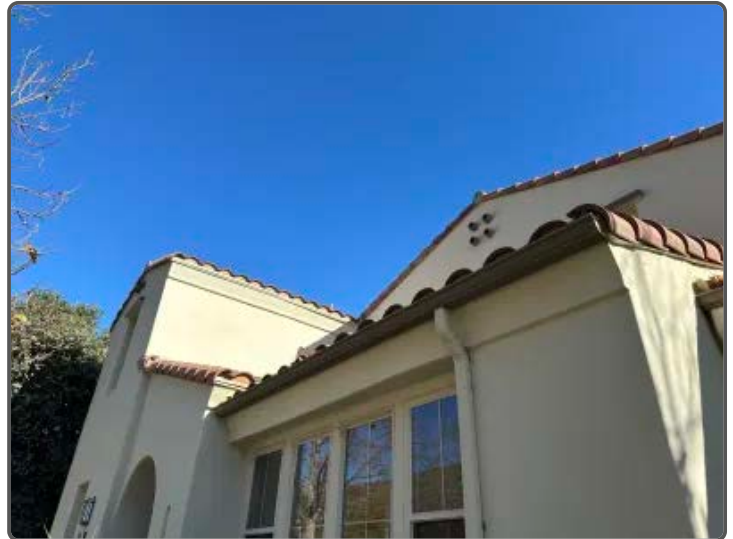
Comp # 905 Fire Heading - Perform

It was reported that the CAM will be performing fire prevention measures to the townhomes in the near future. No expectation to repeat this project. We have therefore funded for this project as a one-time expense.

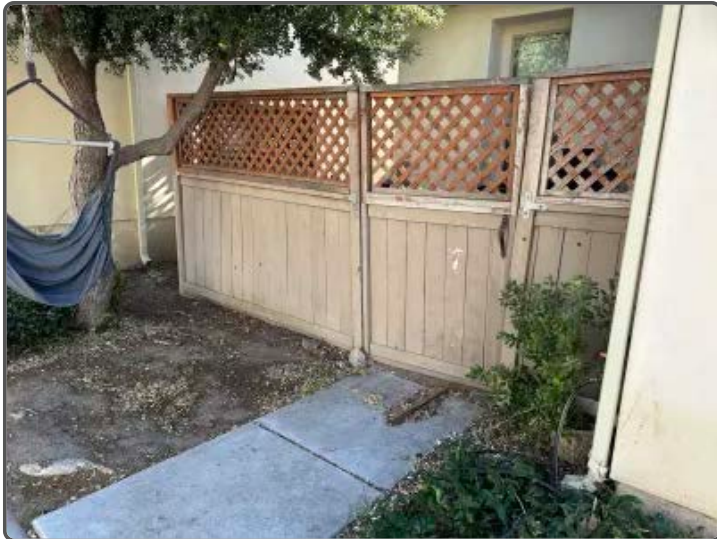
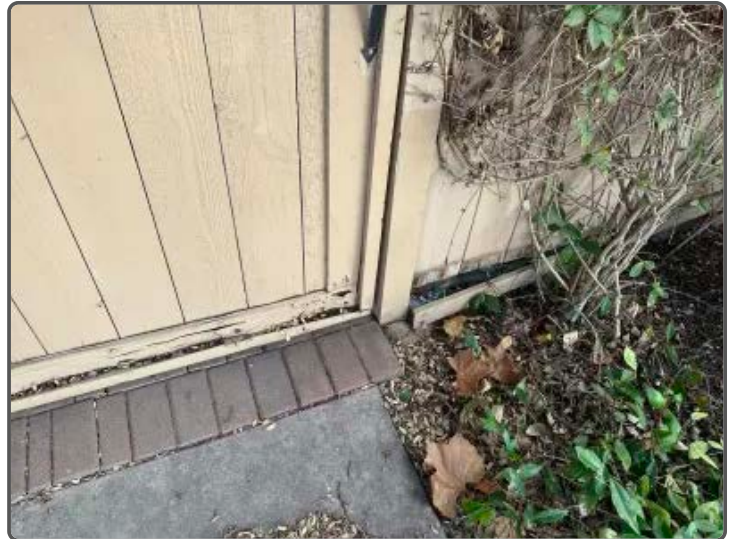
Comp # 1001 Wood Fencing / Gates - Replace

It was reported that this fencing will be replaced with a metal product in the near future. Once replaced expect a useful life of approximately 20 to 25 years from this fencing.

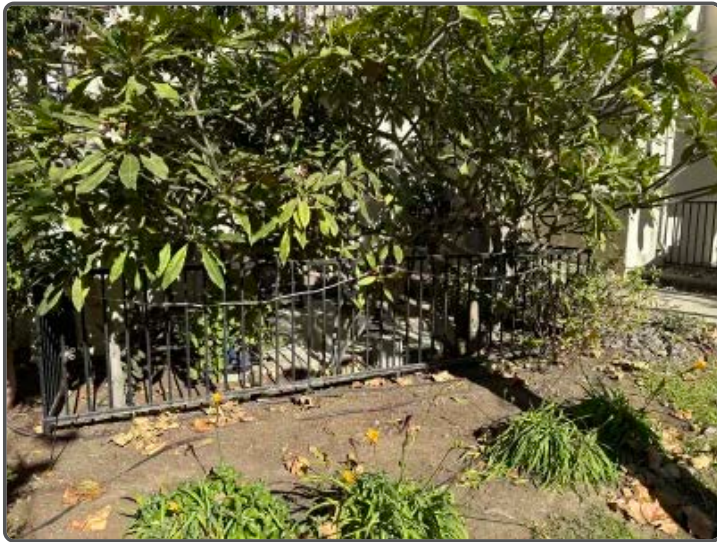
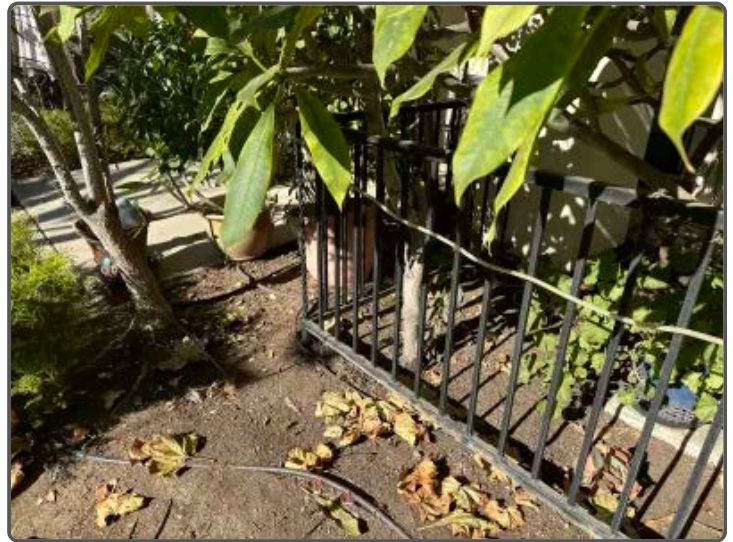
Comp # 1002 Wrought Iron Fencing - Replace

Noted areas of rusting and some structural issues with the wrought iron patio fencing. Expect to make local repairs to this fencing at the same time as the repainting project and funding for more significant repairs and replacements every 25 to 30 years.

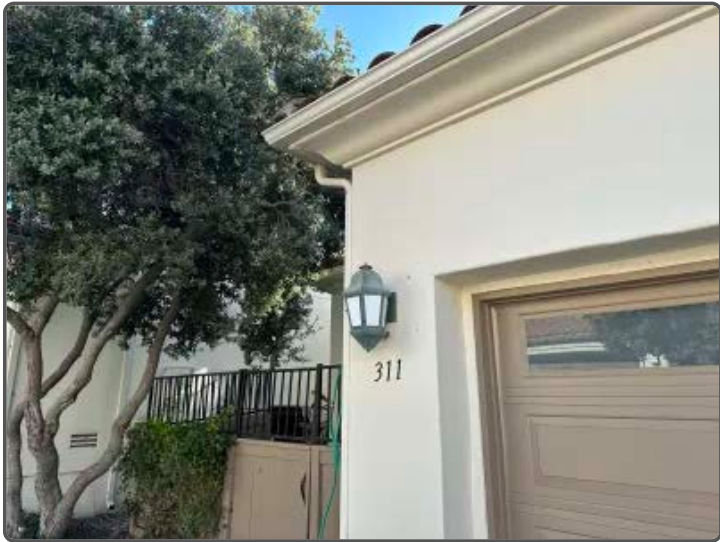
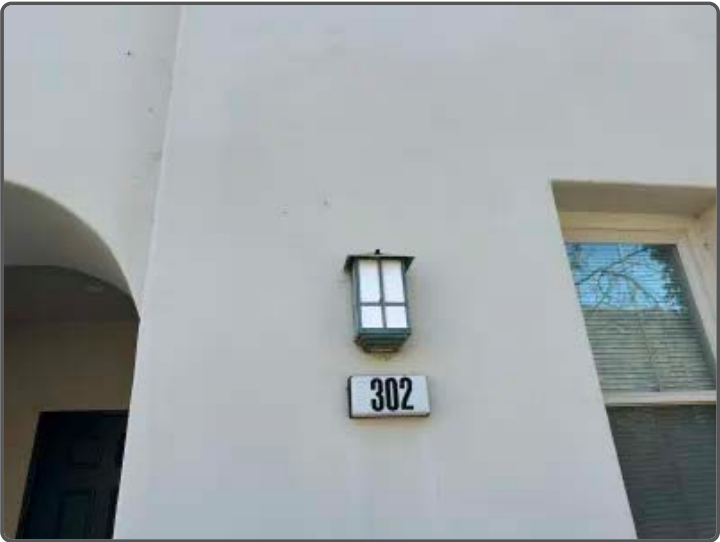
Comp # 1602 Exterior Lights - Replace (Operating Expense)

It was reported that these lights will be repaired and replaced using operating funds. No reserve funding necessary.

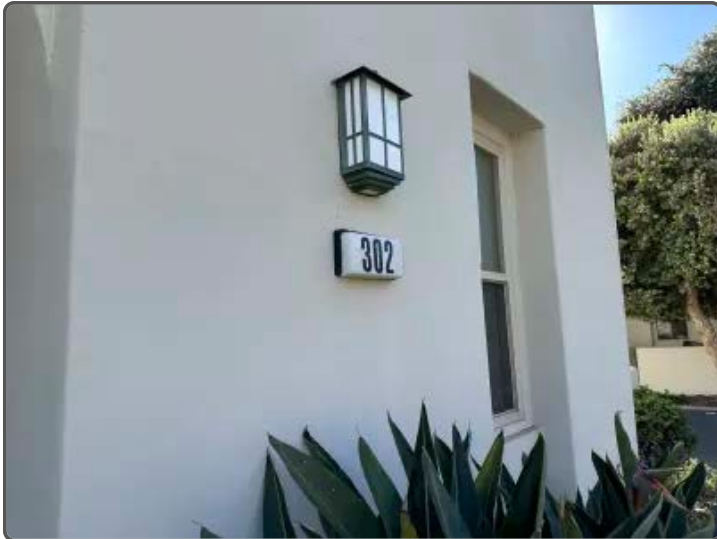
**Comp #** 1690 **Illuminated Unit Signs - Replace**

It was reported that these signs will be replaced in the near future. Once replaced expect a useful life of approximately 15 to 20 years from these signs.

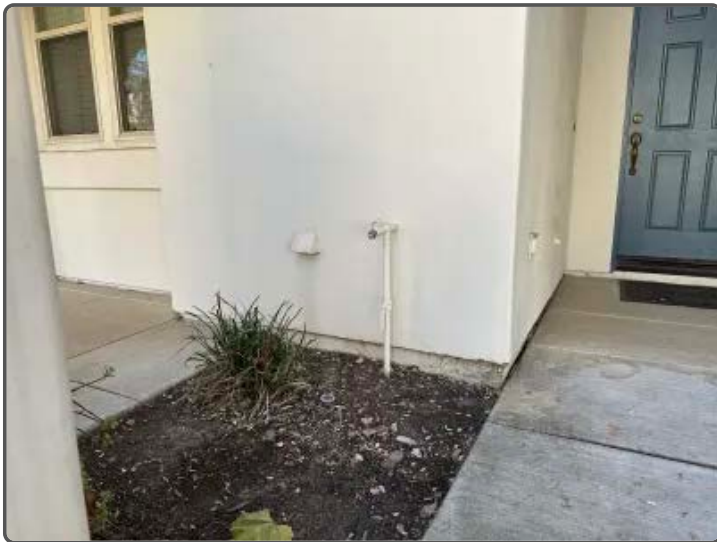
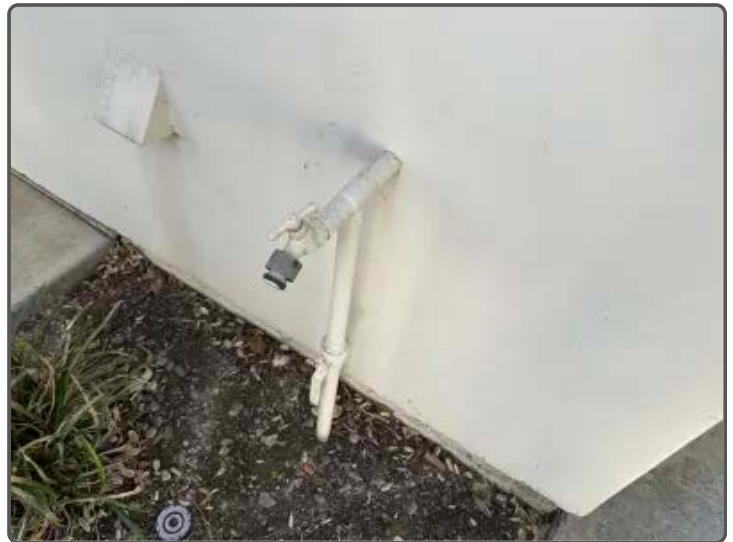
It was reported that the townhouses have experienced slab leaks in the phase 2 constructions in recent years. Although the useful life of the unit distribution plumbing is difficult to predict we recommend funding to make significant repairs to the distribution plumbing approximately every 35 to 40 years. This line item represents the 149 units located in phase 1 (2002) and phase 3 (2006) of construction.

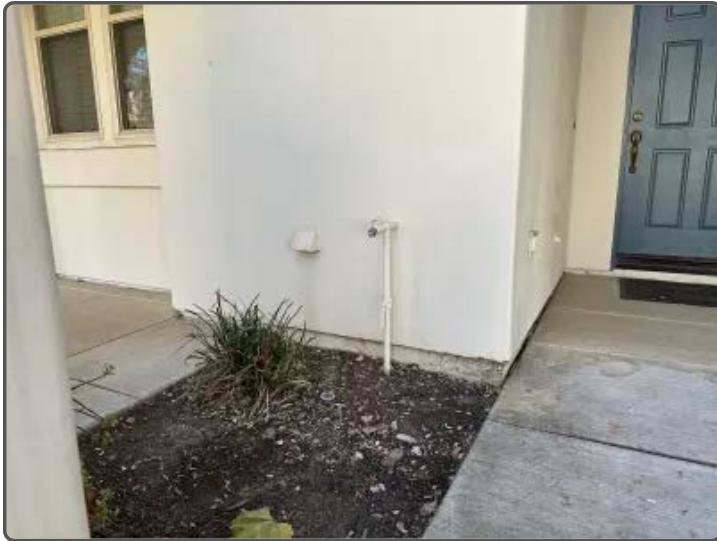
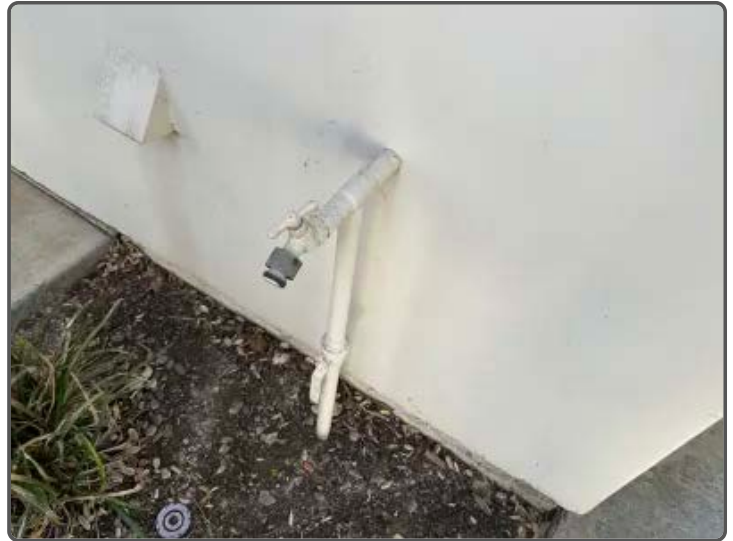
Comp #      2002      Units - Re-pipe (Construction Phase 2)

It was reported that the townhouses have experienced slab leaks in the phase 2 construction (2004) in recent years. We recommend funding to re-pipe the phase 2 of construction in the next 10 years based on current condition.

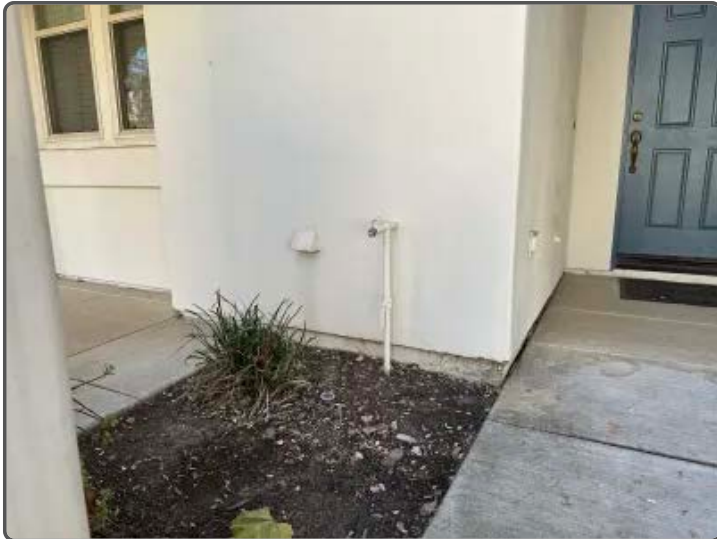
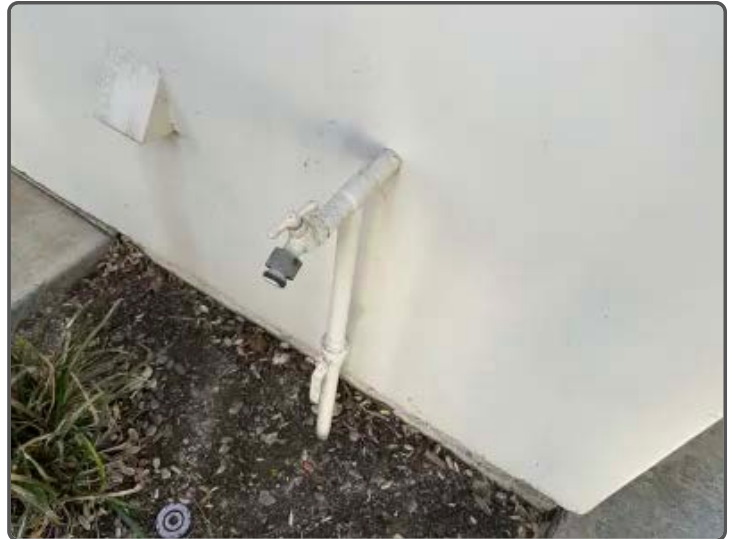
Comp #      2002      Units - Re-pipe (Construction Phase 2)(FY2026)

It was reported that the CAM intends to re-pipe 20 of the phase 2 units this fiscal year. We have funded for a similar project approximately every 35 to 40 years.

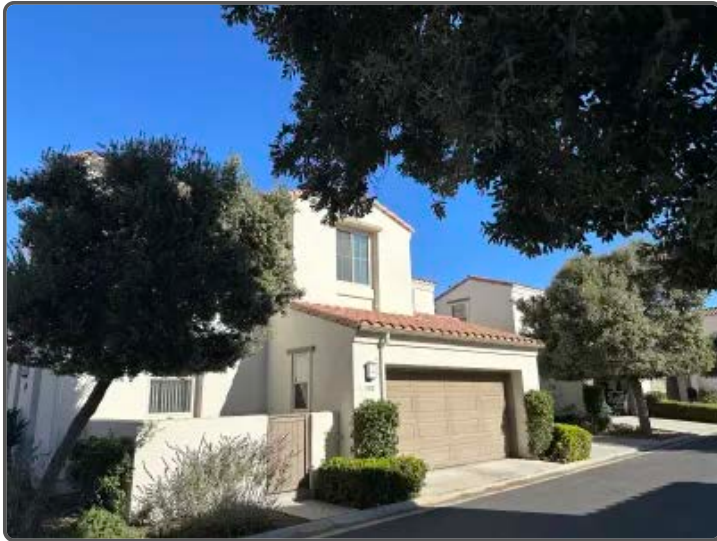
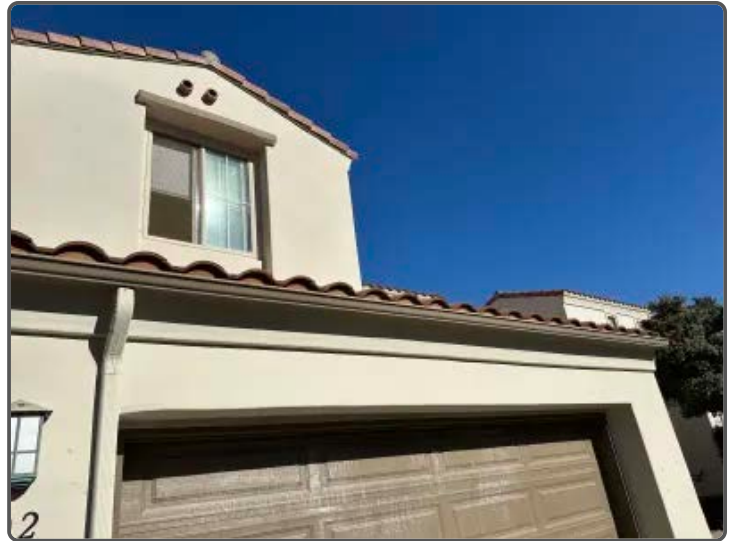
Although the necessity to perform this project is difficult to predict we have funded for an allowance for termite inspections and local treatments approximately every 5 years.

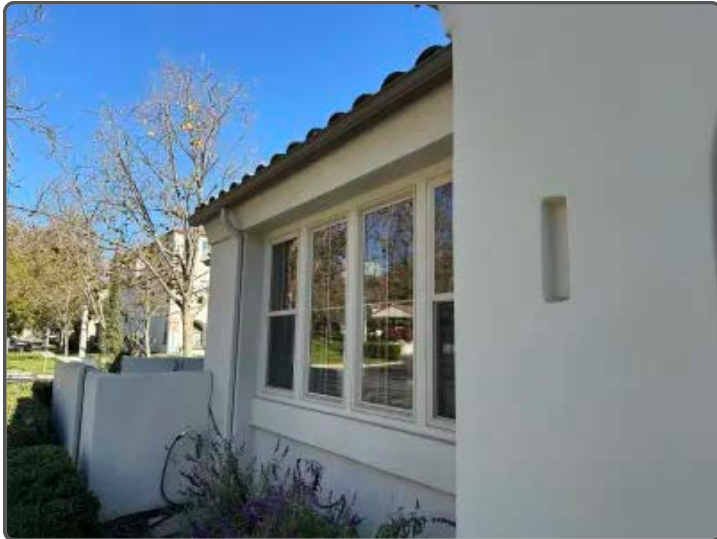
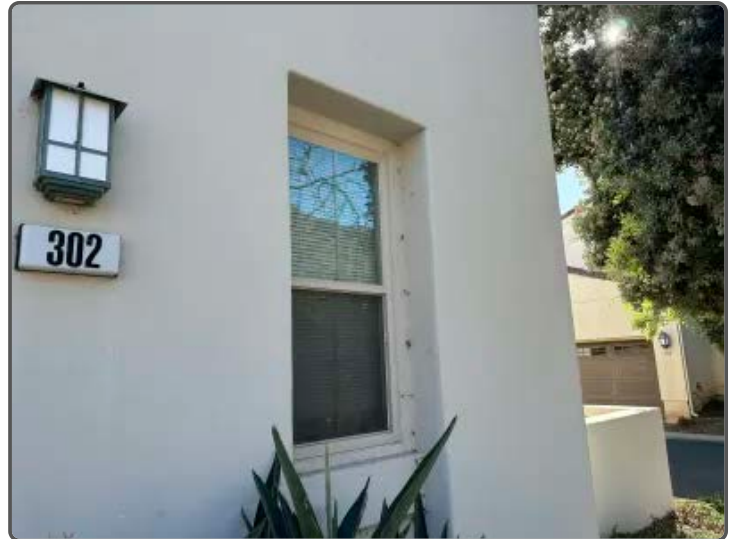
Comp # 2301 Windows - Replace

No problems noted with the windows and doors. Although this component may experience an extended life we recommend funding for significant replacements approximately every 35 to 40 years.

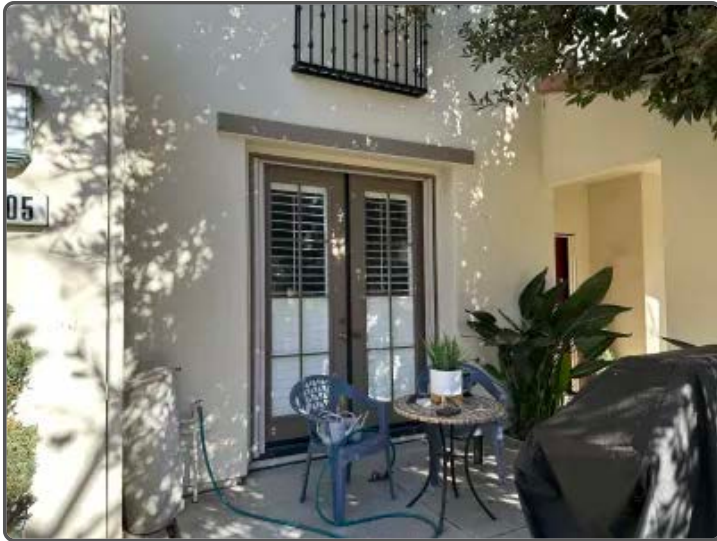
Comp # 2302 French / Sliding Doors - Replace

No problems noted with the French/sliding doors. Although these doors may experience an extended useful life we recommend funding for their replacement approximately every 30 to 40 years.
